Service Bulletin No. SB 06-2-23

## **MANDATORY SERVICE BULLETIN**

**Subject:** Safelying of standard and flop-type fuel pickup tubes.

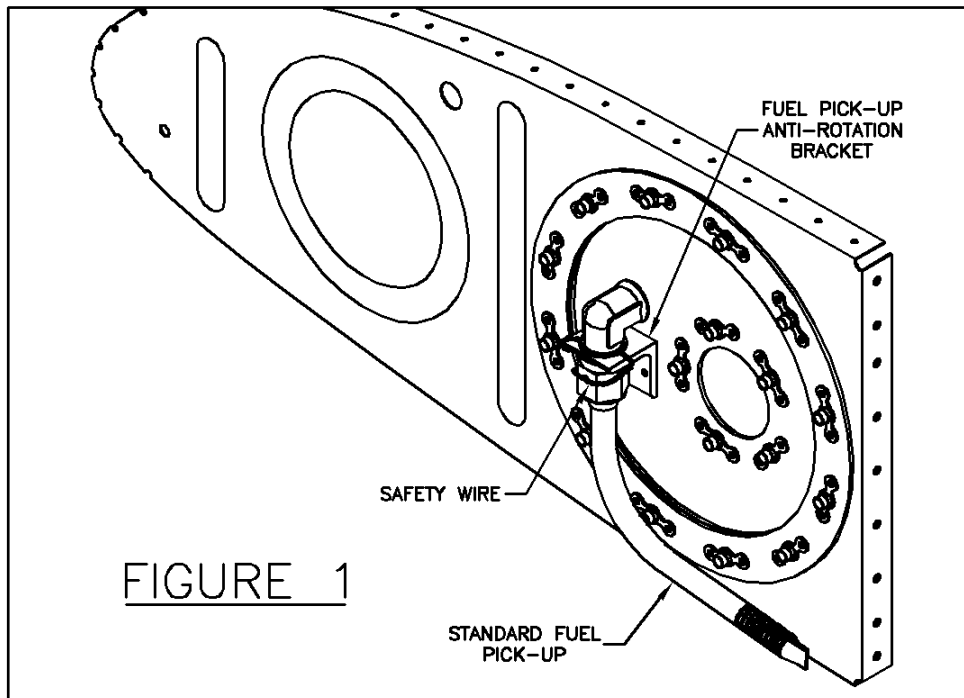
13. Reinstall the pickup tube and verify that it is positioned as shown in Figure 1.
14. Torque the AN818-6D coupling nut on the pickup tube to 110-130 in.lb.

11. Remove the fuel pickup tube. Slide the AN818-6D coupling nut back from the AN819-6D sleeve and flared tube end.
12. Drill a hole in the AN818-6D coupling nut as shown in Figure 2 to allow installation of safety wire.

15. Safety wire (.032" wire) the AN818-6D coupling nut to the bulkhead fitting as shown in Figure 2.
16. Before installing the T-408 cover plate, check the security of the AN818-4D coupling nut attaching the vent line to the inboard rib inside the tank. This fitting should have a torque of 50-65 in.lb.

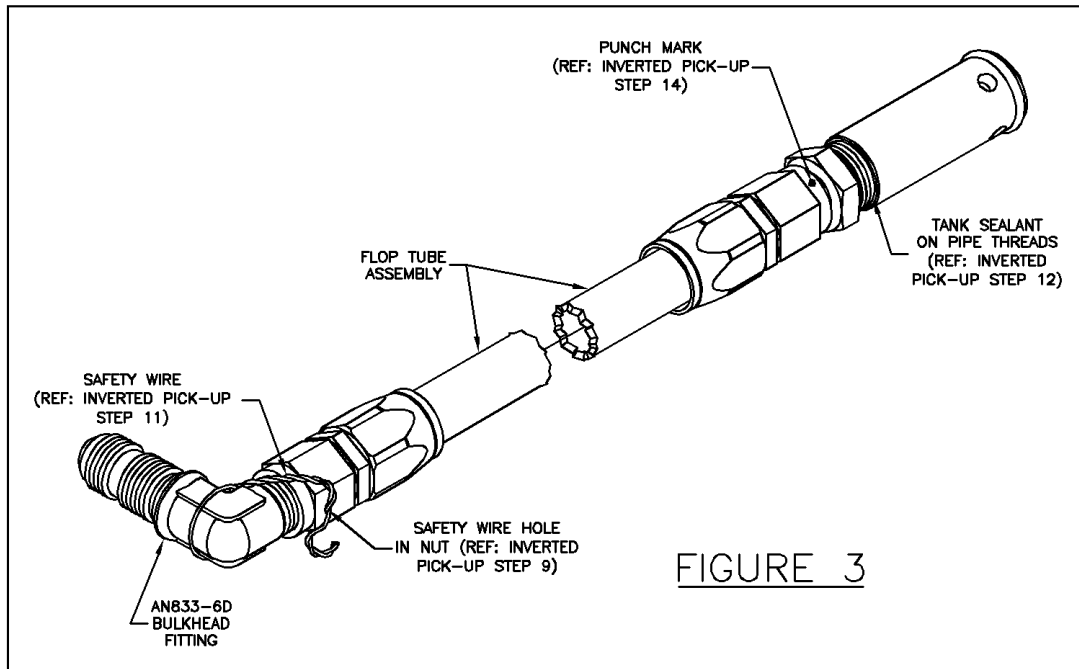
7. Remove the flop tube/bulkhead fitting assembly from the fuel tank.
8. Remove the flop tube from the bulkhead fitting.
9. Drill the nut on the flop tube hose end as shown in Figure 3.

10. Clean any tank sealant from the components and re-assemble the floptube to the bulkhead fitting.
11. Safety wire the nut to the bulkhead fitting as shown in Figure 3.

13. Check the security of the nut attaching the weight to the floptube and safety as described below.
14. Using a small punch and hammer, make a punch mark on the 'weight end' nut of the floptube. Punch the flange of the nut as shown in Figure 3. The punch mark should be deep enough to effectively lock the nut in position.
